Report Number C19621-1

***Re: Retaining Wall Assessment
250 Ledbetter Lane
Franklin, NC***

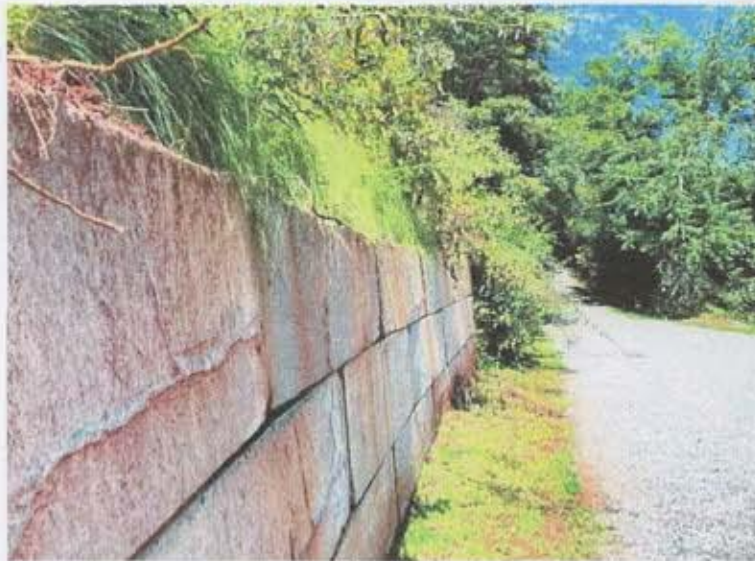
Photo 1

I was told by you that the wall was newly constructed to aid in the slope failure repair. It was my understanding that poor drainage uphill of your home caused surface water to overflow ditches and culverts installed along and across Ledbetter Lane. No permit was obtained for the wall construction. An engineer was not consulted for an engineered wall design. The wall is approximately 5' tall and retains a nearly 1:1 slope (100% grade). The wall is constructed of precast 2'x2'x6' dry stack concrete blocks. The wall is leaning several inches out of plumb. No gravel footing was observed. No geogrid soil/wall reinforcement was observed. No wall drainage was observed. The wall is improperly constructed and failing it is at risk of collapse. See Photos 1-3 of the retaining wall.

A new properly engineered and permitted retaining wall should be constructed. The wall should be of sufficient height to allow for a maximum of a 2.5:1 slope (40% grade) *behind and above the wall*. The *design of the retaining wall, slope, and erosion control measures* are beyond the scope of this report.
